Effect of Armoring a Cohesive Nearshore with a Thin Cobble Lag, Shoreham, Michigan

PURPOSE: This Coastal and Hydraulics Engineering Technical Note (CHETN) summarizes monitoring results of the 1995 lake bed paving project conducted at Shoreham, MI, on Lake Michigan by the U.S. Army Engineer Research and Development Center (ERDC), in collaboration with The U.S. Army Engineer District, Detroit. The CHETN also discusses the effectiveness of lake bed paving in reducing cohesive lake bed downcutting and mitigation of bluff erosion. The lake bed paving concept was examined as an innovative alternative to traditional revetment construction to protect the shoreline.

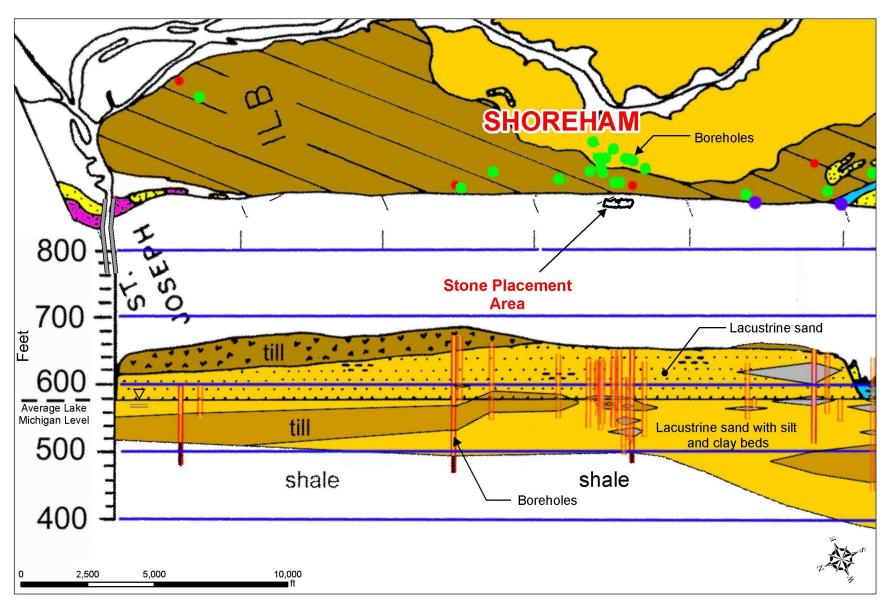
Figure 3. Surficial geology and stratigraphic structure south of St. Joseph Harbor (after Larson 2005).

Geomorphic and Geological Conditions. Larson (2005) has produced a plan view of the surficial geology together with stratigraphic sections for the study area north and south of St. Joseph Harbor based on information collected and interpreted since more than 20 years ago. The surficial geology and stratigraphic structure along a 10-km (6.2-mile) reach south of the harbor including Shoreham has been reproduced in Figure 3. In general terms, the area immediately south of the harbor consists of three primary units: lacustrine sand sandwiched between an upper till at the surface and a lower till at and below the lake level. The bluff height is about 27.4 m (90 ft) through half of this reach and diminishes to 21.3 m (70 ft) at about 5 km (3.1 miles) south of the harbor where the upper and lower till layers no longer exist and only lenses of clay appear within a lacustrine sand body. The average bluff height is about 18.3 m (60 ft). There are lenses of clay in the lake bed just around the Shoreham area, which was exposed at the time of stone placement representing a cohesive shore.

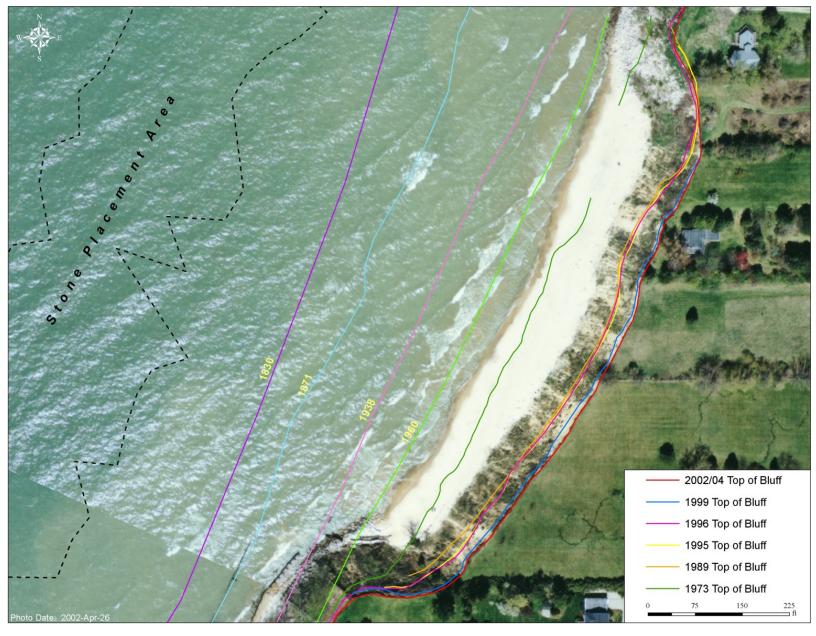
Figure 4. Historic top of bluff lines at Shoreham, MI.

Top of bluff lines were digitized from the registered air photographs and historical charts. Digitizing was performed by using Heads Up Digitizing (HUD) in ArcMap 9.0. For registered photographs with a scale of 1:6,000, digitizing was done at a map scale between 1:1,000 and 1:2,000. For photographs or charts with a smaller scale (e.g., 1:10,000 or higher), a smaller map scale was used (e.g., 1:2,500 – 1:5,000). Figure 4 shows the bluff line comparison results for the period between 1830 and 2004. It may be seen that the bluff has been eroding continuously at this site. The long-term average recession rate is estimated at 0.9 m/year (2.9 ft/year). Since the placement of stone layer, the bluff has continued to erode between 1995 and 1999 and between 1999 and 2002.

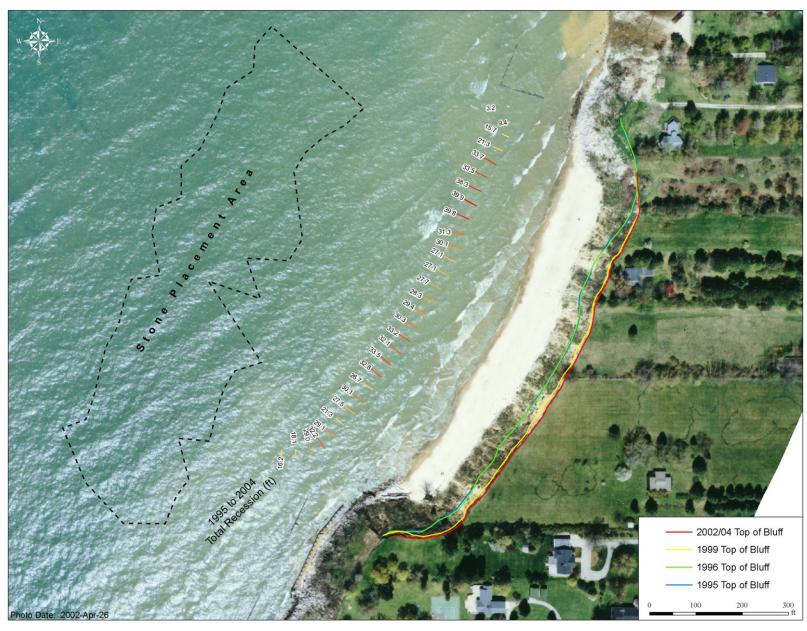
Figure 5. Bluff recession at Shoreham, MI, between 1995 and 2004.

Figure 5 shows bluff recession details since completion of stone placement project to present. Total recession between 1995 and 2004 for every 10 m (32.8 ft) along the Shoreham bluff are also given in this figure. Average total recession is 8.4 m (27.6 ft), which translates to a recession rate of about 0.9 m/year (3 ft/year) close to its long-term average. In this figure, the 2002 and 2004 lines are identical, i.e., there was no bluff erosion between these years likely because of recent low lake levels. During low lake levels there is little or no direct wave attack on the bluff face, which explains the growth of vegetation on the bluff face. During periods of high lake levels the bluff face is much steeper with little or no vegetation.

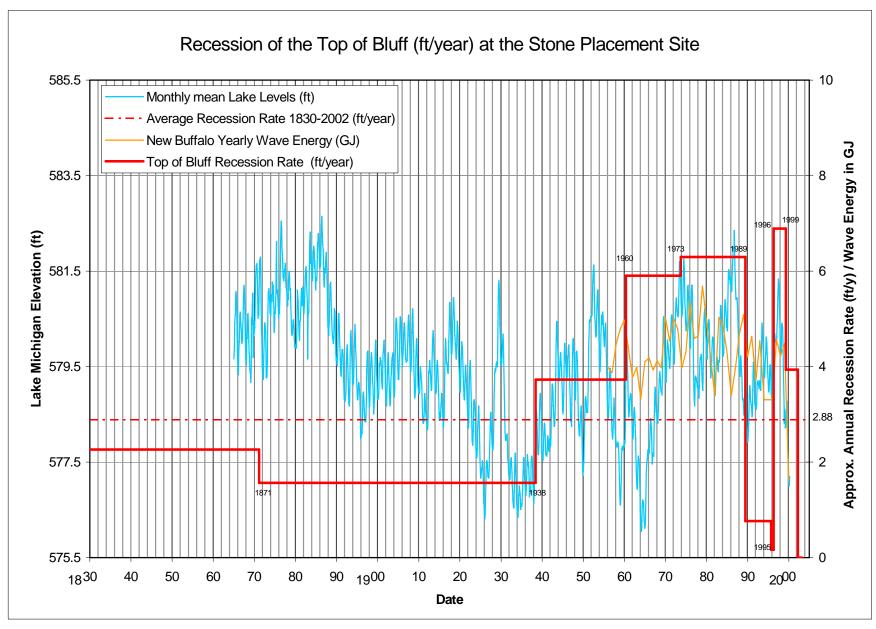
Figure 6. Bluff recession rate at Shoreham, MI, and Lake Michigan levels.

Using this information, the historic retreat rates for periods between each available and reliable snapshot were calculated at Shoreham. Figure 6 provides: (a) time along the x-axis from 1830 to present; (b) the estimated bluff crest retreat rate (referenced to the left hand scale), which appears as a step function as it relates to the change in the bluff position between snapshots taken at the beginning and end of each segment; (c) the average bluff retreat rate for the period from 1830 to 2004; and (d) the lake level variations from 1830 to present. In general, higher retreat rates have occurred during periods of high lake levels.

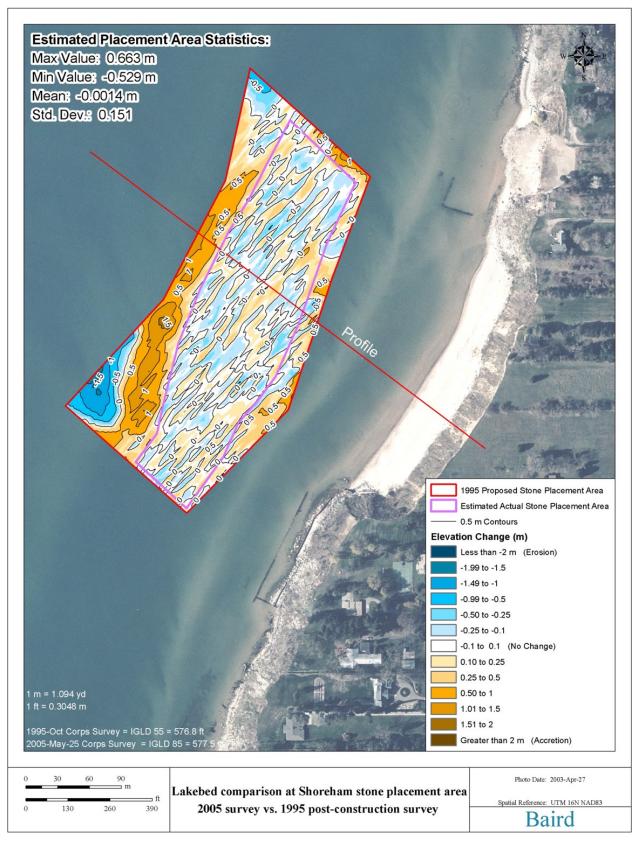
Figure 7. Surface comparison between 1995 and 2005 USACE surveys.

Figure 7 shows the surface comparison between the 2005 survey and the 1995 post-construction survey. The light blue and yellow area represents an area with relatively small or no change and should therefore correspond to the stone placement area. The purple box in this figure is the estimated stone placement area based on this comparison. The average elevation difference in the stone placement area (purple box) is -0.0014 m (-0.005 ft), which is within the accuracy of the surveying techniques. The stone surface has therefore been stable over the 10-year period since construction.

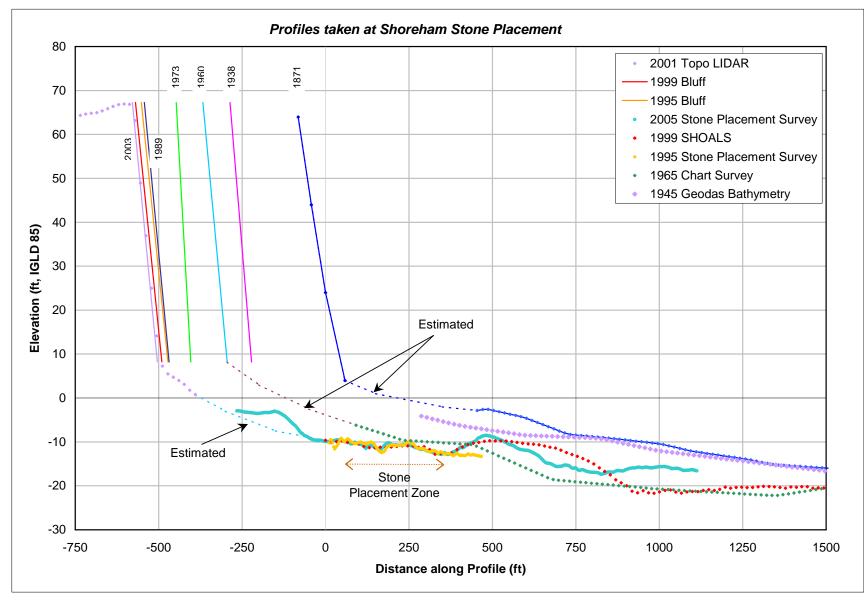
Figure 8. Historic and recent nearshore profiles at Shoreham, MI.

Figure 8 shows the data along the profile line indicated in Figure 7, together with other survey data and bluff lines. None of the data sets provide data in shallow water. Therefore, part of the nearshore bathymetry in this figure had to be estimated. It may be seen that lake bed lowering had continued between the 1871 and 1965 surveys. The lowering, however, stopped sometime after 1965, and the 2005 survey shows some sand accumulation on the lakeward side of the stone layer. This is likely because of the U.S. Army Corps of Engineers' beach nourishment activities downdrift of St. Joseph Harbor since 1970. A bar is also observed shoreward of the stone area in the 2005 survey.

From Figure 8, it may be seen that the stone surface is at about 3 m (10 ft) below LWD. Hindcast data for other nearby projects indicates that the wave climate in the area is calm for about 30 percent of the time (40 percent when ice is included), and wave height is less than 2 m (6.6 ft) for about 55 percent of the time. Thus, for a total of 85 to 95 percent of the time the wave height is less than 2 m (6.6 ft). Consequently, most waves propagate over the placed stone surface without energy dissipation. As downcutting is believed to be proportional to the rate of wave energy dissipation, it is therefore unlikely that the stone layer has had any effect on reduction of downcutting between the stone placement area and the shore. Moreover, downcutting rate increases as the depth decreases towards the shoreline, and it is the downcutting rate in shallow water close to the bluff toe which controls the bluff erosion (Philpott 1984; Davidson-Arnott 1986; Kamphuis 1987). It is therefore concluded that the present paving was placed too far offshore. Unfortunately, the deep placement was necessary because of the barge and equipment used at the time. Lake bed paving would be more effective if placed in shallower waters close to the shoreline.
